Stromness Conservation Area

Stoica, R & Kartalou, N 2014, *Stromness Conservation Area: Building and Landscape Survey*. Orkney Islands Council.

STROMNESS CONSERVATION AREA

Building and Landscape Survey
July, 2014

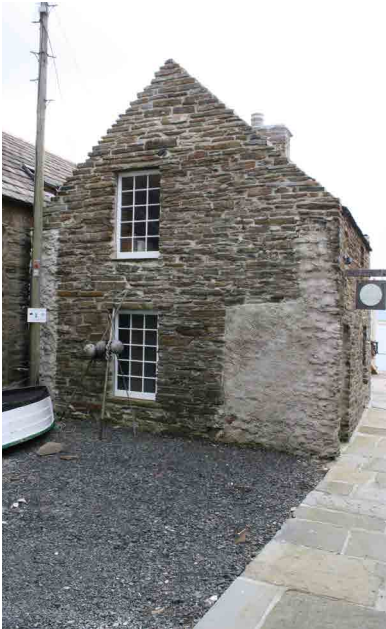
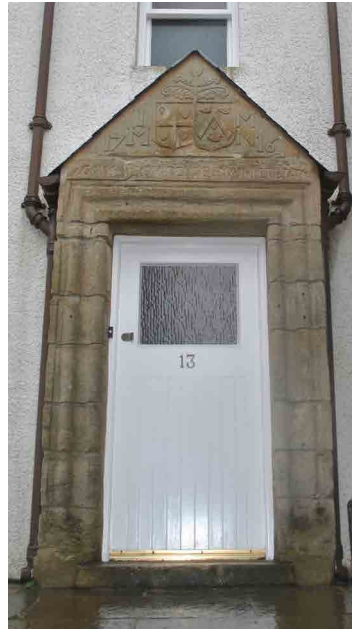
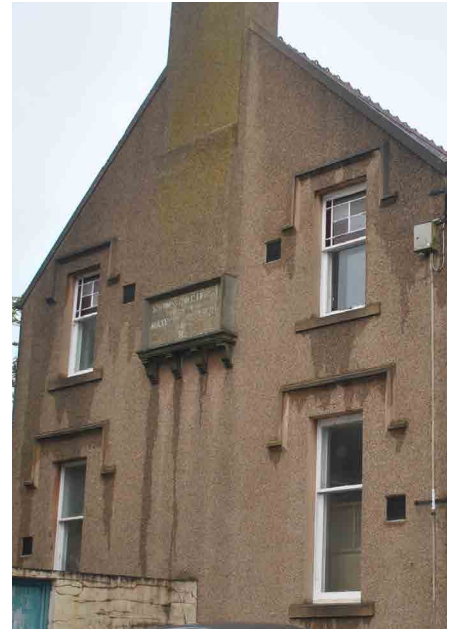
• 26 Render/Pointing Condition

Most of the structures have their render or pointing in a good or fairly good condition and do not need to be redone or monitored. 10% of structures display a poor condition of render or pointing.

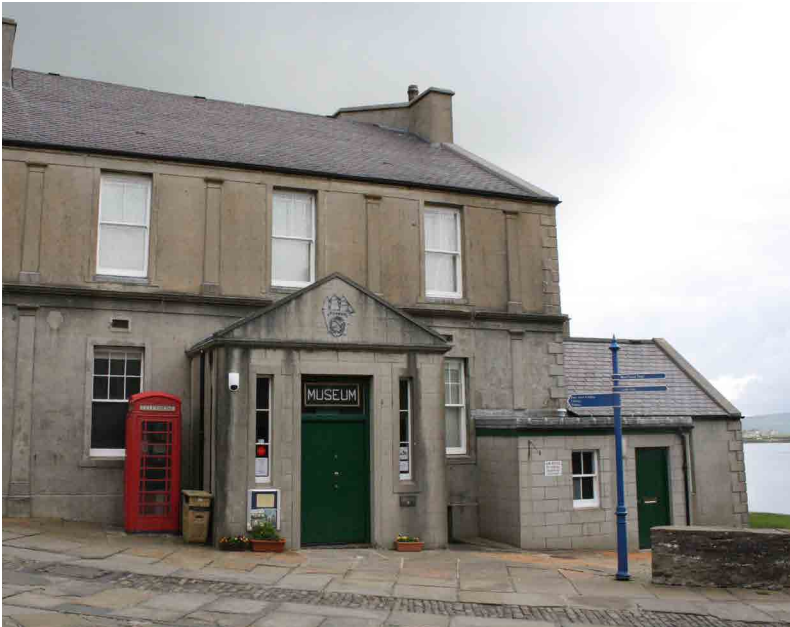
Fig 36. Alfred Street

Being a largely residential area, it is not surprising that most of the doors within the research area are of timber. While the majority of the doors appear to be panelled, many of the structures also have boarded doors.

Very few doors are made of plastic material and a small number of metal doors are used mainly for structures such as warehouses or storage areas, or for the buildings at the harbour.
